**Re: Buckman Direct Diversion Project; Major Industrial; SIC 4941; NPDES Compliance  
Evaluation Inspection; NPDES # NM0030848; April 3, 2018**

## NPDES Compliance Inspection Report

**Compliance Evaluation Inspection**  
**Buckman Direct Diversion NPDES Permit No. NM0030848**  
**Inspection Date: April 3, 2018**  
**Further Explanations**

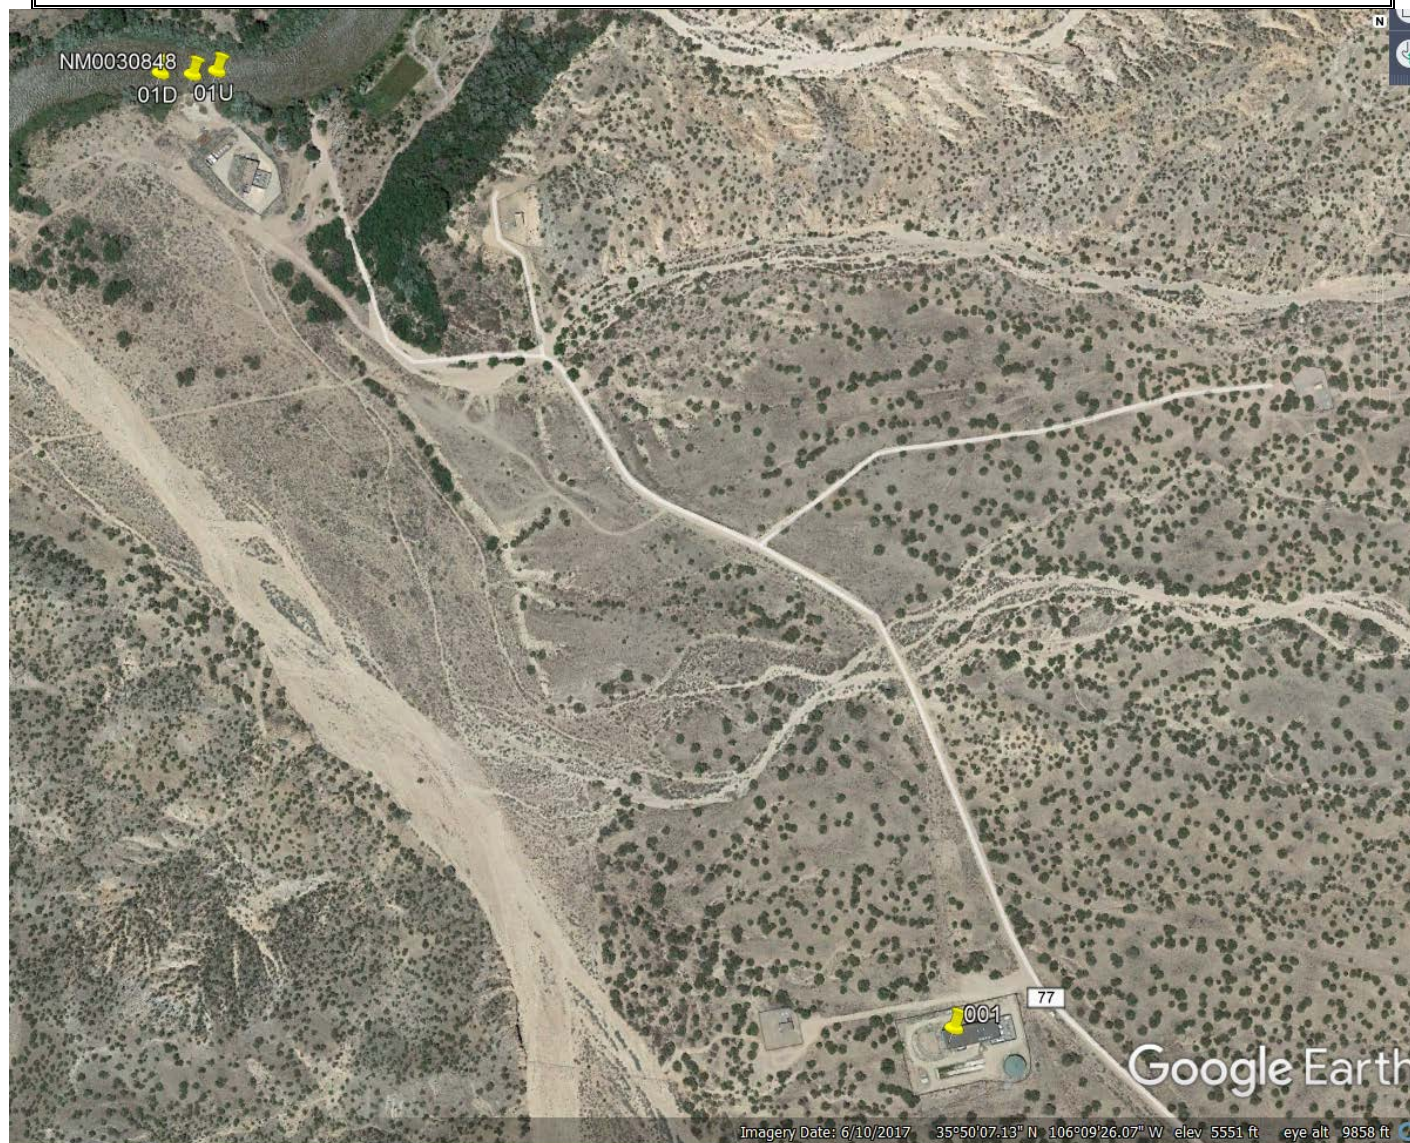
| NMED/SWQB<br>Official Photograph Log<br>Photo # 1 | | |

| Subject: Sampling locations at Rio Grande and Sediment Removal Facility (SRF) building | | |

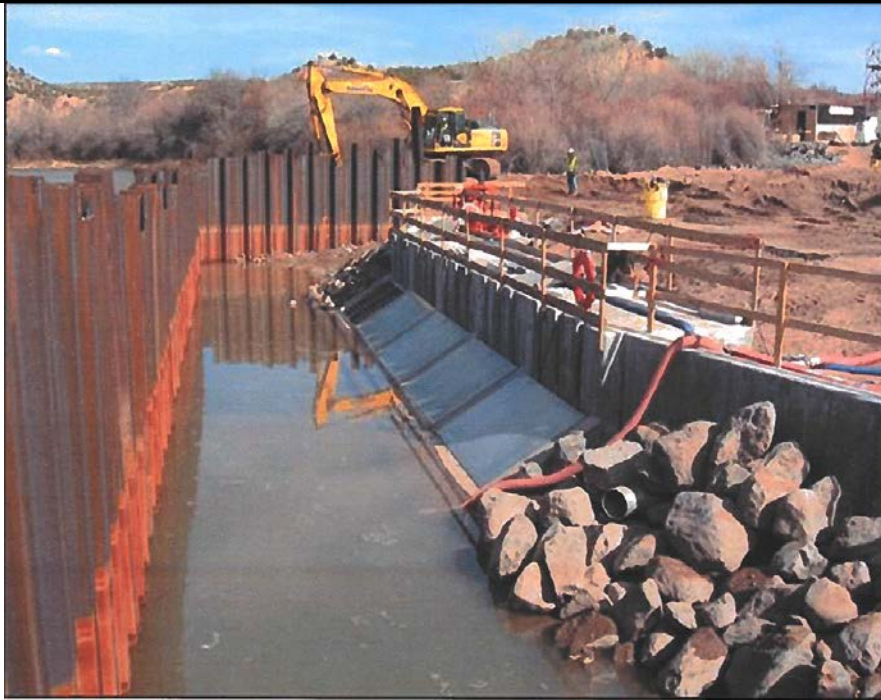
| NMED/SWQB<br>Official Photograph Log<br>Photo # 2 | | |

| Subject: grey pipe on right is outfall during construction (which is now underwater) | | |

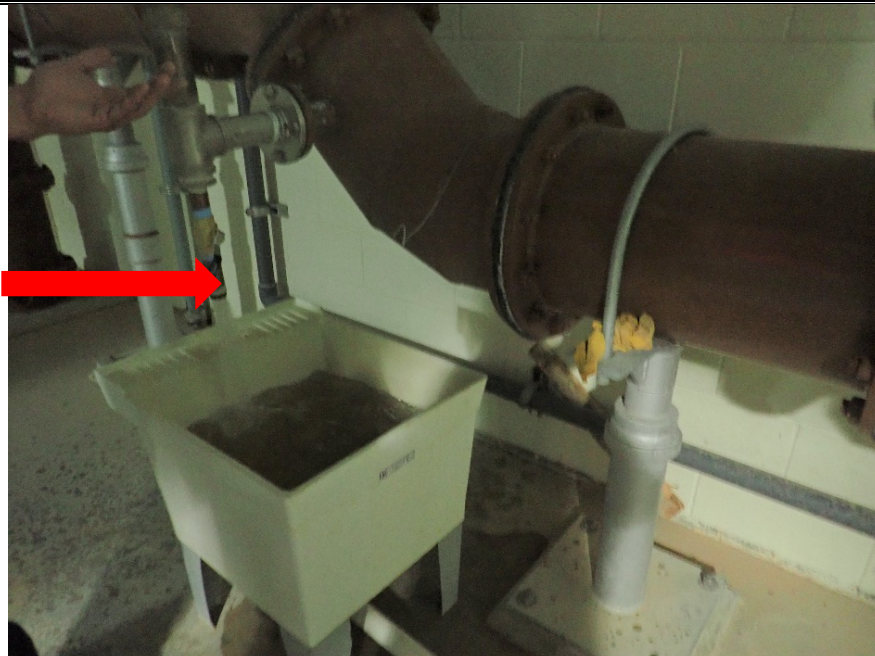
| NMED/SWQB<br>Official Photograph Log<br>Photo # 3 | | |

| OUTFALL NO. | OIL SHEEN | GREASE | TURBIDITY | VISIBLE FOAM | FLOAT SOL. | COLOR | OTHER |
|---|---|---|---|---|---|---|---|
| 001 | none | none | light | none | none | none | |

RECEIVING WATER OBSERVATIONS: Observed at sampling port on Sediment Return Line (SRL) inside the Sediment Removal Facility (SRF) building (photo 3)

| Subject: discharge observation at sampling port 001 on Sediment Return Line (SRL) inside the Sediment Removal Facility (SRF) building | | |

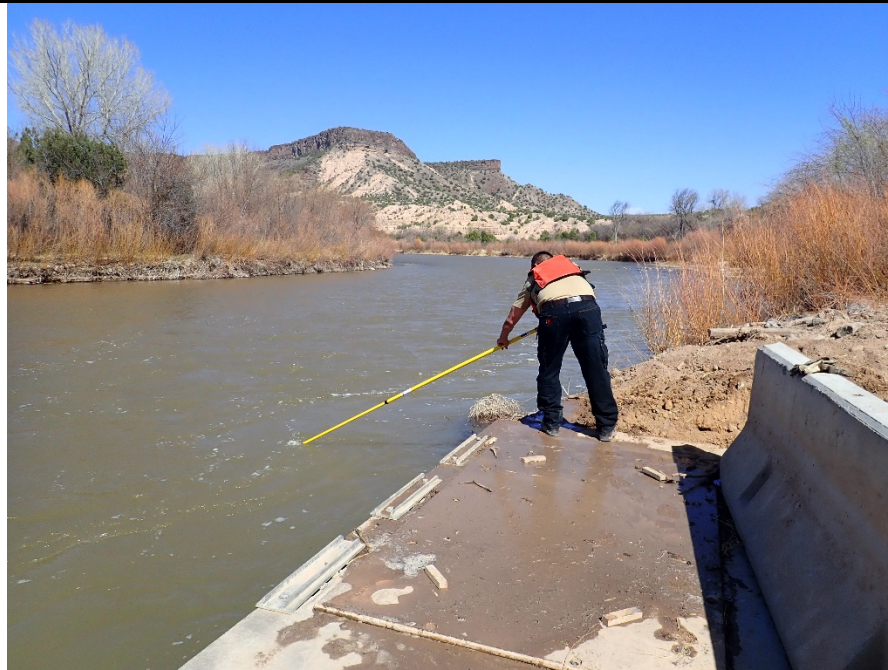
| NMED/SWQB<br>Official Photograph Log<br>Photo # 4 | | |

| Subject: Sampling location 01U-upstream of intake | | |

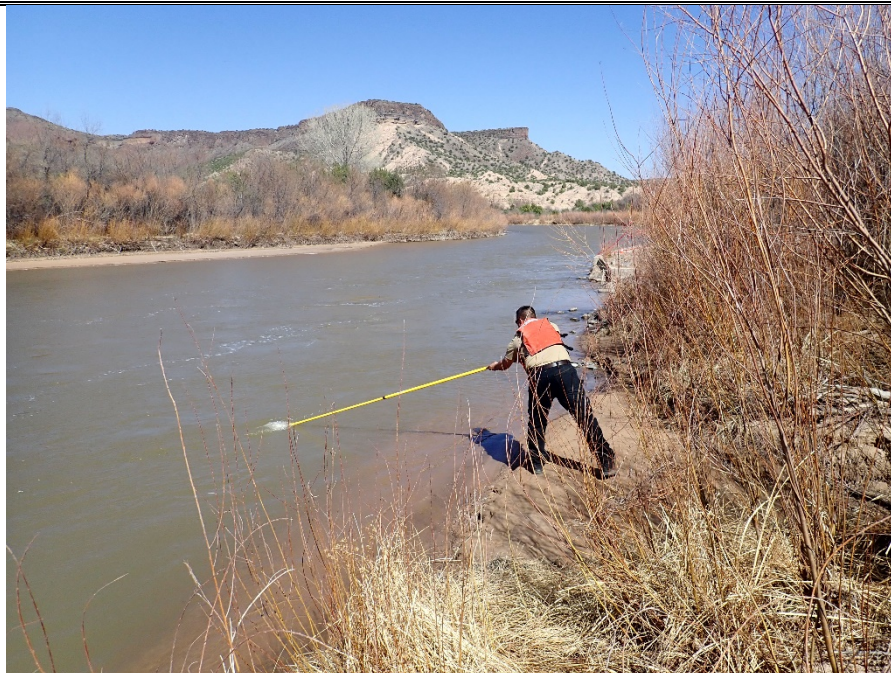
| NMED/SWQB<br>Official Photograph Log<br>Photo # 5 | | |

| Subject: Sampling location 01D-downstream of outfall (visible in stream above sampler) | | |
